Bumper/Fascia Replacement with Advanced Driver Assistance Systems (ADAS)

June 2018

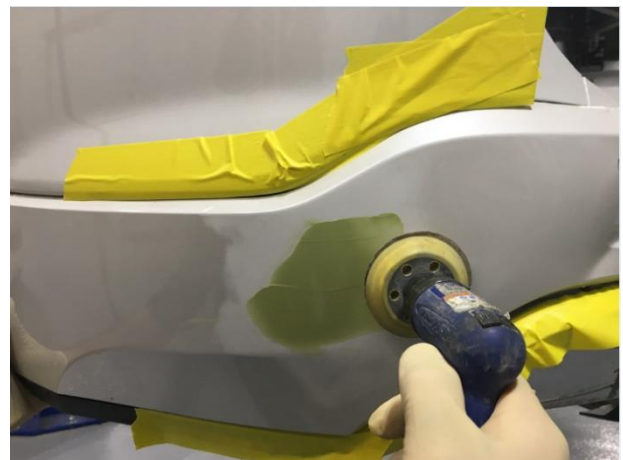
Any Bumper/Fascia equipped with ADAS(s) that requires substrate repair must be replaced. An example of substrate repair is shown in Figure 1.2
